**Minnesota
Pollution
Control
Agency**

455 Hardman Avenue Site

A Part of the Former Van Hoven/Armour Rendering Site
South St. Paul, Dakota County, Minnesota

A success story involving the MPCA's Petroleum Brownfields and Voluntary Investigation and Cleanup programs (A Part of Project Nos. VP2474, VP2471, VP2472, VP2473 and PB3834)

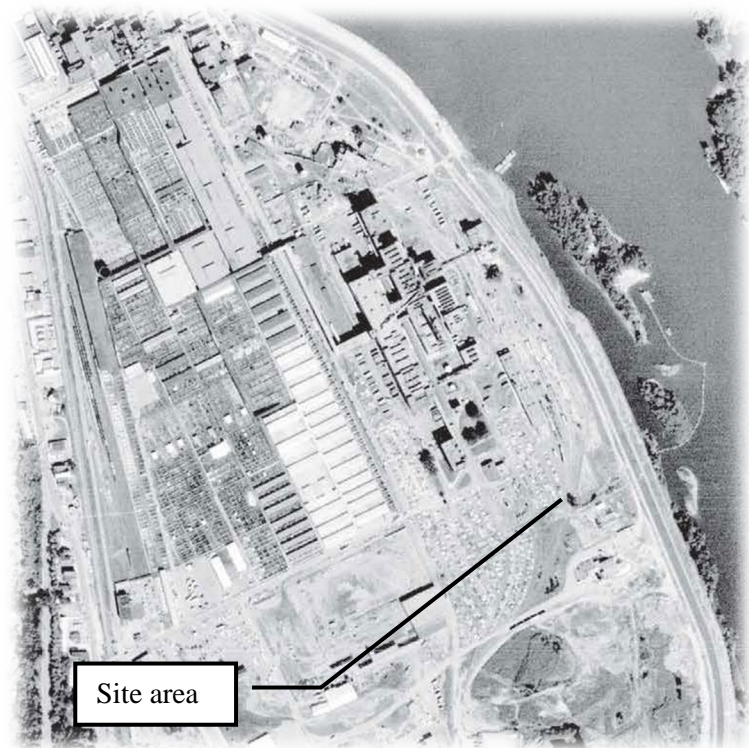
1970 aerial photograph from the Phase I ESA, dated June 2007 by Landmark Environmental. The site is on the southern boundary of the historic Armour & Company meat-processing facility.

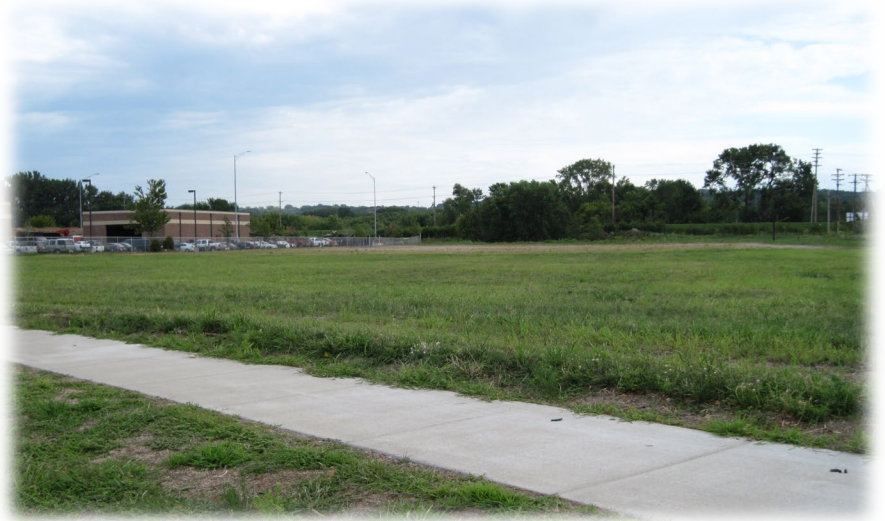
Soil response actions have been completed at the site, which is now ready for a new building.

- All on-site buildings were demolished and the demolition debris was removed from the site.
- Approximately 20,600 tons (about 750 truckloads) of contaminated soil and debris were excavated and disposed in a permitted landfill.

- A stormwater retention pond was installed on the eastern portion of the site to accommodate future redevelopment of the site.
- Future buildings will require a methane mitigation system if soil gas sampling shows there are still elevated methane gas levels in the subsurface.
